Using SnapshotNIR to Assess HBOT for Wound Healing

Presented by: Jonathan A. Niezgoda, CHWS, and Jeffrey A. Niezgoda, MD

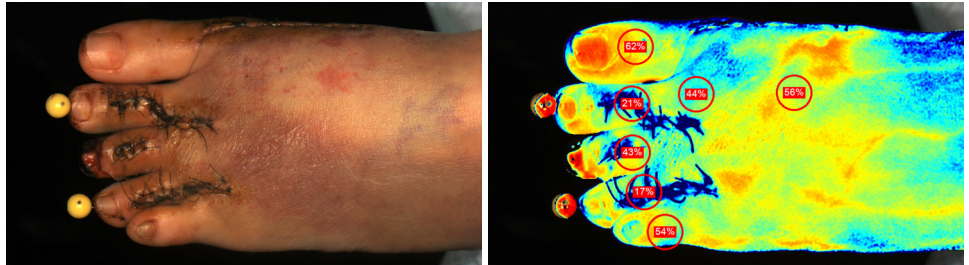
Fig 1. 01/09/2019: Baseline image of the dorsal surface of the foot with ischemic and necrotic tissue due to arterial insufficiency. Pre-first session of HBOT.

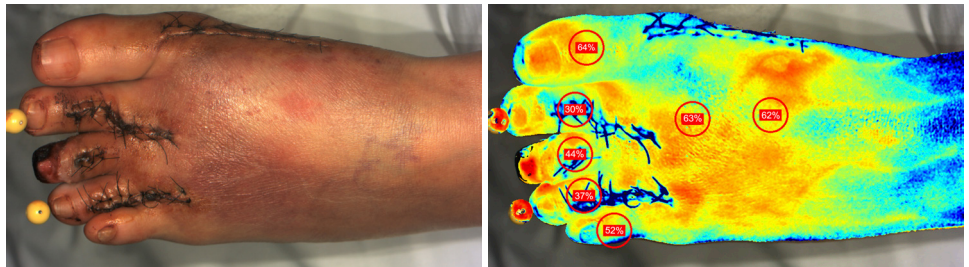
Fig 2. 01/09/2019: Post-initial session of HBOT. Note the increase in oxygenation following the dive.

Significant improvement in oxygenation was observed following HBOT and the patient reported improvement in her pain following HBOT and vascular intervention. HBOT was continued and the patient was monitored serially. The patient continued to show improvement over the next several weeks and the suspected necrosis of D3 ultimately proved to be only superficial tissue loss, which was predicted through the NIRS images. Several weeks past the initial event, the eschar managed to slough, and the entire digit survived and remained viable. The patient was very pleased with this outcome.

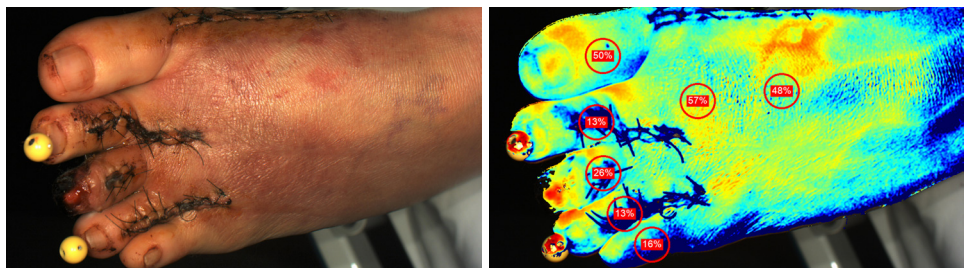
Fig 3. 01/10/2019: Pre-second session of HBOT.

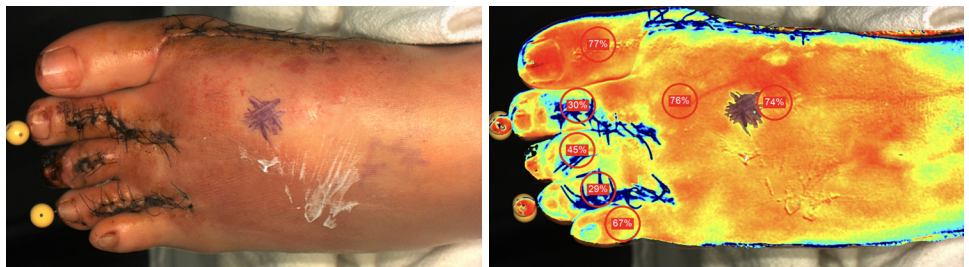
Fig 4. 01/10/2019: Post-second session of HBOT. Note the increase in oxygenation.

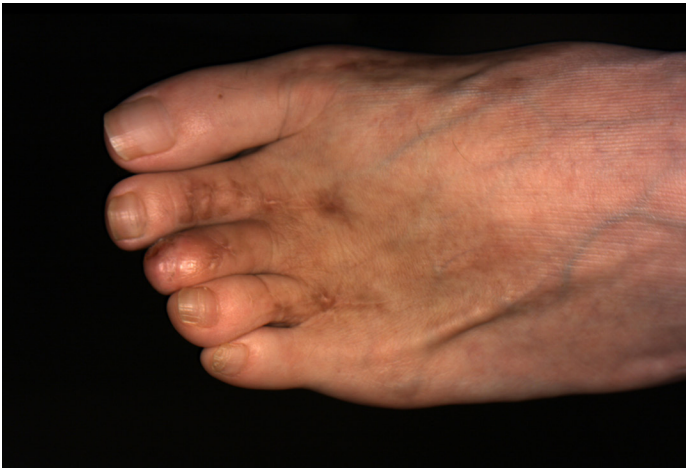
Fig 4A. 7/21/2019: Clinical image of the dorsal surface of foot post-22 sessions of HBOT and vascular intervention.

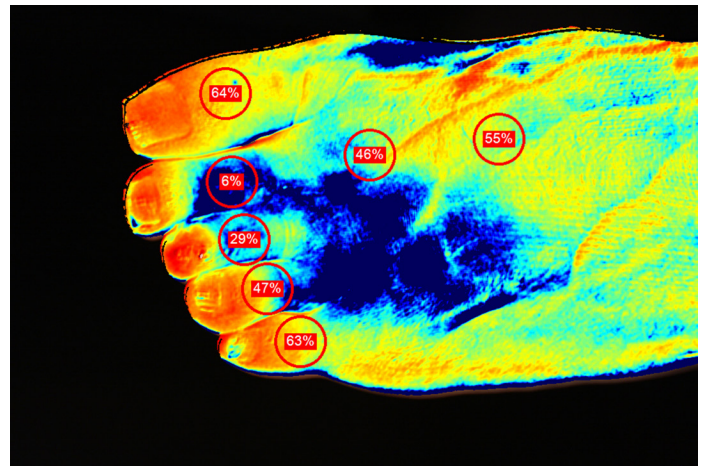
Fig 4B. 7/21/2019: S_tO_2 image of the dorsal surface of foot post-22 sessions of HBOT and vascular intervention.

"The use of NIRS, in this case, demonstrated the improvement in S_tO_2 values following vascular intervention and HBOT. Significant improvement in S_tO_2 pre- and post-HBOT treatment 1, as well as serial improvement over time, correlating positively with the clinical impression that digit salvage effort was possible. This strategy prevented a digit amputation for the patient."
