# CASE STUDY SERIES

## Using SnapshotNIR for early identification & prevention of ulcers

### CASE 1: Focused identification of shear force and pressure in advance of ulcer formation

## CASE 2: Focused Offloading to Prevent Recurrent Ulcers

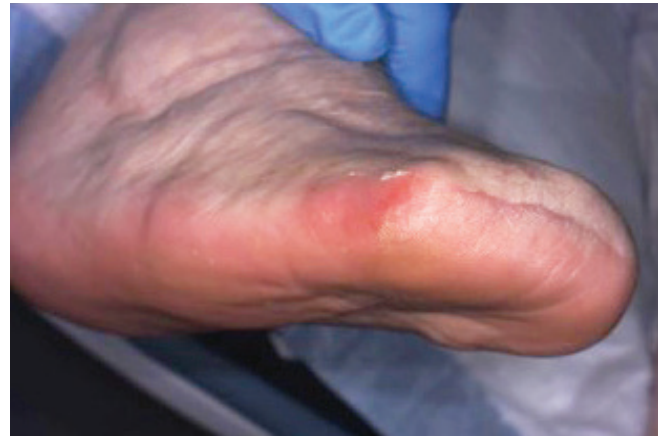
SnapshotNIR images in April show increased oxygenation over her fifth metatarsophalangeal joint, suggesting increased perfusion due to an inflammatory tissue response from pressure and shear forces. The hemoglobin view of the same image set confirms this observation with

the elevated values for oxyhemoglobin over the joint compared to the surrounding tissues.

*Note the decrease in excessive tissue oxygen saturation ( $S_tO_2$ ), which represented inflammation, over the pressure point after 5 weeks of offloading.*

*Also note the normalization of the oxyhemoglobin markers around this pressure point in the lower right pane of the hemoglobin view image.*

Focused offloading and footwear modification was monitored using the Snapshot imaging. Decreases in inflammation correlated with improved offloading and a reduction in pressure and shear forces. Early detection and intervention on areas of increased inflammation identified with Snapshot prevented foot ulcer formation.

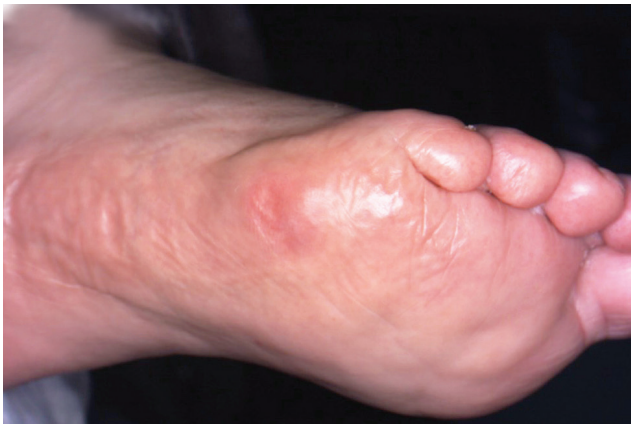
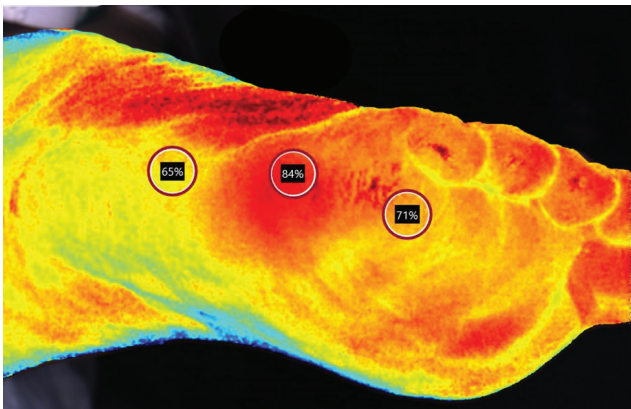
The clinical image (top) and the  $S_tO_2$  image (bottom) of the patient's right foot. SnapshotNIR captures both the clinical and  $S_tO_2$  image simultaneously. Users can toggle between the images or view side-by-side.

With the NIRS imaging, we were able to observe a moderate increase in oxygenation over his 5<sup>th</sup> metatarsophalangeal joint (MTPJ) when compared to his surrounding tissues. The hemoglobin view images also identified a contrast in values of oxyhemoglobin when comparing the MTPJ with surrounding tissues.

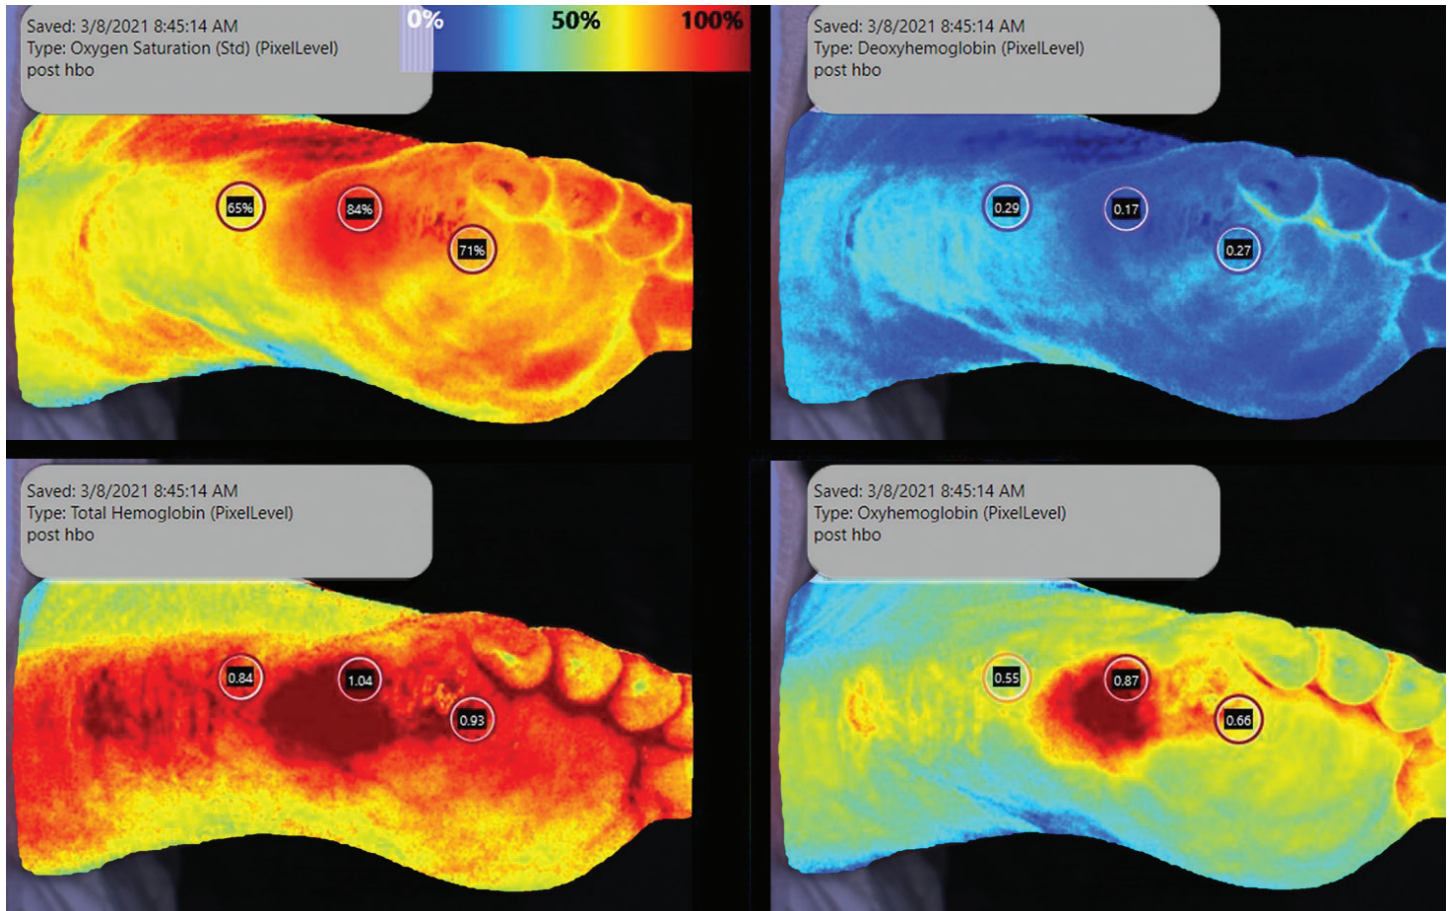
Notice the areas of increased oxygenation indicating significant inflammation in patient's right foot lateral to the 5<sup>th</sup> metatarsophalangeal joint. Note the oxyhemoglobin markers in the lower right pane of the hemoglobin view image.

The Snapshot images identified areas of increased oxygenation and tissue perfusion suggesting significant inflammation in his right foot lateral 5<sup>th</sup> metatarsophalangeal joint, matching the wound location on his left foot. These changes are reflective of tissue trauma due to pressure forces. Early identification of an area at risk for pressure injury allowed intervention with enhanced pressure redistribution efforts including repositioning and increased foot padding avoided further tissue damage and prevented ulceration.
