Verifying a Complete Debridement Using SnapshotNIR

Presented by: Erin Buchness, MHL, RN, DAPWCA

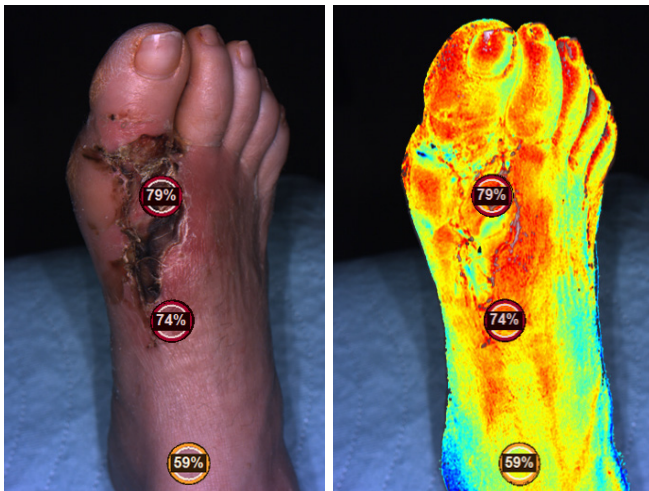
Fig 1: Baseline image of the dorsal surface of the right foot with a post-operative ulcer after an elective bunionectomy. Pre-debridement images.

SnapshotNIR was utilized during the initial evaluation in the wound center to establish the patient's baseline tissue oxygen saturation (S_tO_2) levels. NIRS images were captured to assess the wound's response to debridement, and to monitor S_tO_2 levels at the ulcer base and peri-wound.

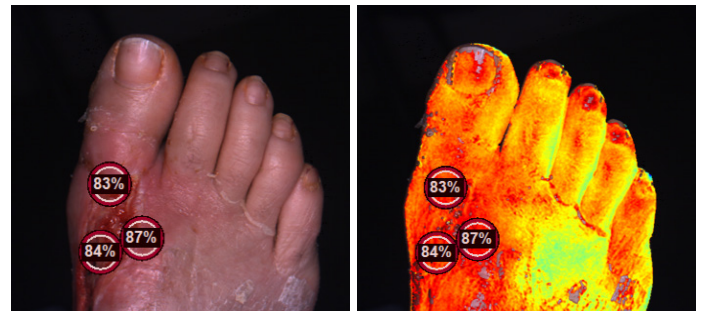
Fig 2B: Week 1: Post-debridement images of the healing foot ulcer. Note the increase in oxygenation.

Through the interpretation of the SnapshotNIR images, it was determined that the patient's increase in oxygenation correlated to the positive response of the debridement, suggesting that the wound would heal with the current treatment plan. Due to the severity of the ulcer and its proximity to the first metatarsophalangeal joint, the patient continued to be monitored pre- and post-debridement.

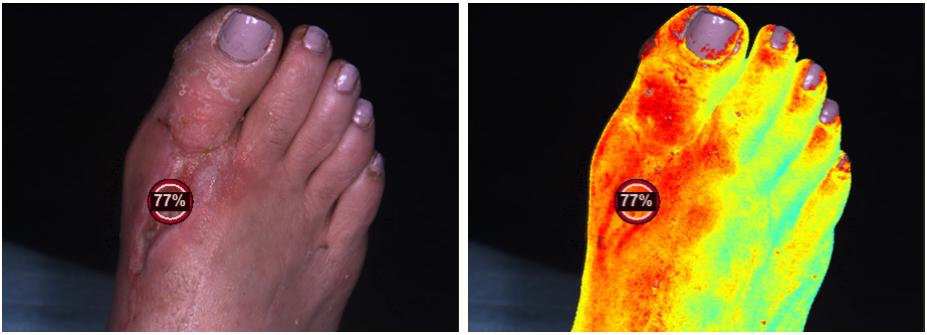
Fig 3A: Week 3: Pre-debridement images of the healing foot ulcer.

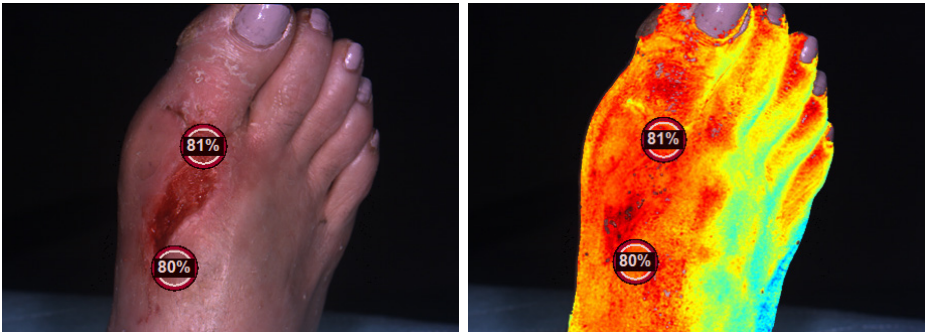
Fig 3B: Week 3: Post-debridement images of the healing foot ulcer. Note the increase in oxygenation.

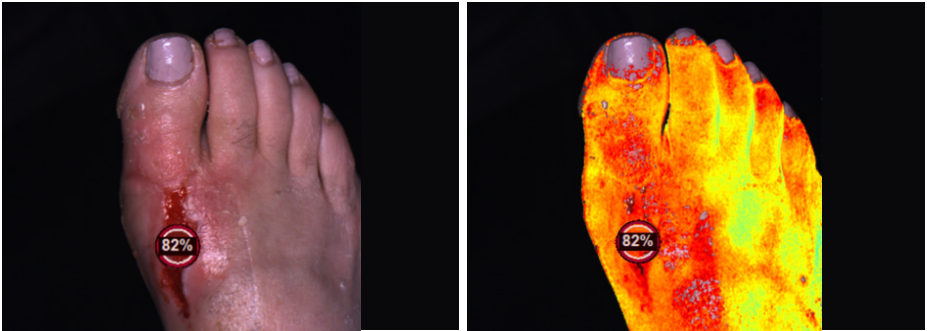
Fig 4: Week 4: Post-debridement images of the healing foot ulcer.

IMPACT:
 SnapshotNIR helped to guide adequate debridement to remove ischemic tissue in the wound bed and peri-wound. It also confirmed adequate oxygenation to support wound healing. The NIRS images allowed the clinicians to deliver focused, patient-specific care. SnapshotNIR assisted in easing the patient’s anxiety about possible toe amputation, reassuring her that her wound would heal, and that she would not need additional surgery.

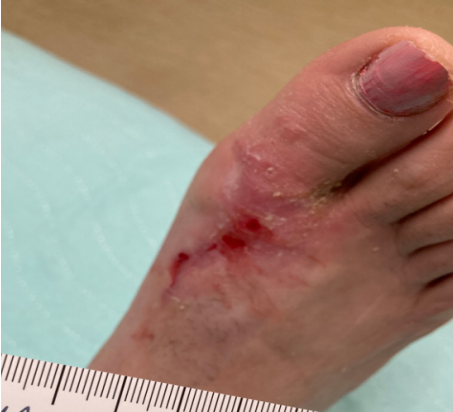
Fig 5: Healed foot after debridements.
