Diabetic Foot Ulcer with Surgical Debridement and NPWT Placement

Presented by: Ronald Ray, DPM, FACFAS, WCC, PT

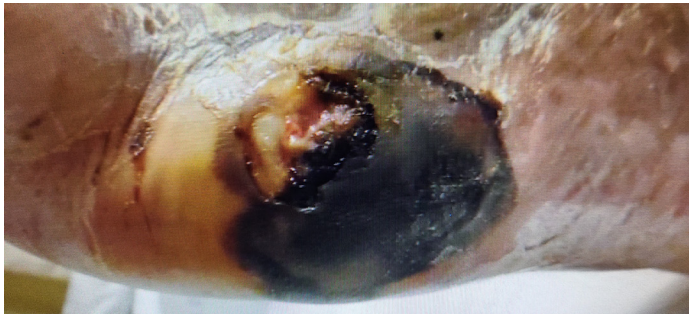
Fig 1. Baseline clinical images of the lateral surface of the left foot with a grade-IV ulceration.

The patient presented with a Grade IV necrotic wound lateral aspect of the 5th metatarsal head of the left foot. He had non-palpable popliteal, dorsalis pedis and posterior tibial pulses and refill to the left foot was 3-4 seconds. He had an absent protective threshold, sharp/dull and light touch in both lower legs and feet. Radiographs of the left foot revealed lucency and lytic changes within the fifth metatarsal head. MRI was performed revealing increased signal in the fifth metatarsal head on T2 weighted images and decreased signal on T1 weighted images consistent with osteomyelitis.

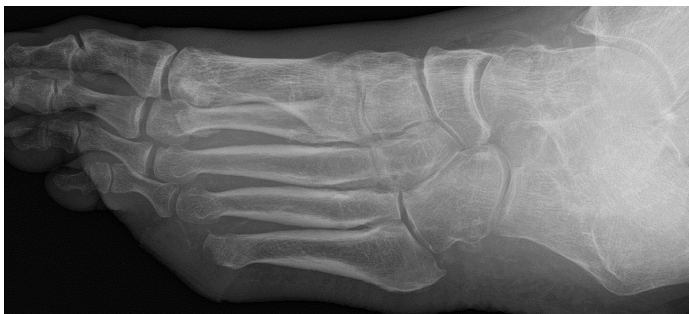
Fig 2. Medial oblique radiograph demonstrating diffuse osteopenia of the fifth metatarsal head with distal lytic changes consistent with osteomyelitis.

Examination raised concern for osteomyelitis. X-ray and MRI studies showed degradative bone changes of the distal 5th metatarsal. SnapshotNIR images were taken to assess the tissue perfusion and oxygen saturation (S_tO_2) of the wound and peri-wound region. The S_tO_2 values on the plantar aspect of the foot ranged from high 50s to mid-70s. The S_tO_2 values on the lateral side of the foot ranged from mid-60s to 80s.

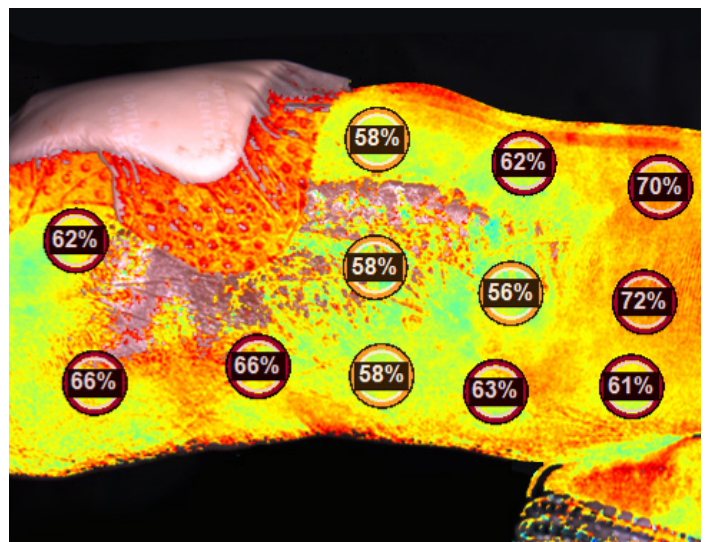
Fig 4B. S_tO_2 image of the plantar surface of the left foot pre-surgical debridement.

The tissue oxygen saturation values indicated adequate perfusion and oxygenation of the tissue and the decision was made to manage with surgical debridement and negative pressure wound therapy (NPWT). Following the NPWT treatment, granulation tissue was achieved over the entire wound bed and the patient healed.

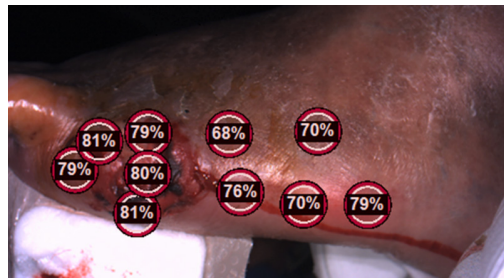
Fig 5B. Lateral surface of the left foot post-surgical debridement. Note the increase in oxygenation.

SnapshotNIR images were utilized to assess the patient’s ability to tolerate a surgical debridement. The NIRS images showed that the area around the wound, as well as the plantar aspect of the foot, were adequately oxygenated. This indicated that the patient would likely respond well to the treatment plan.

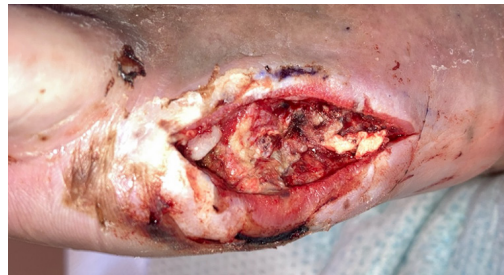
Fig 6. Image of foot post-debridement and pre-NPWT. Fig 7. Image of left foot post-NPWT replacement.
